Inverted Induction Motor and Test Stand

This paper proposes the construction of an inverted induction motor (with the cage winding at the stator), and the test stand associated, to readily monitor rotor parameters and reproduce defects with the intention of optimizing and comparing different techniques of simulation and fault detection.

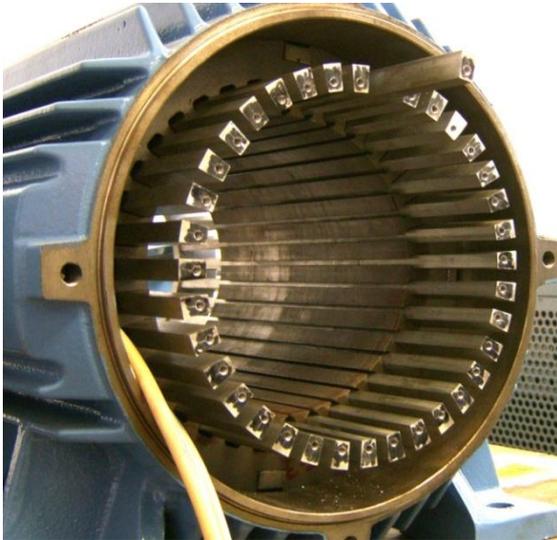
Fig. 1 – Bars placed in the stator slots.

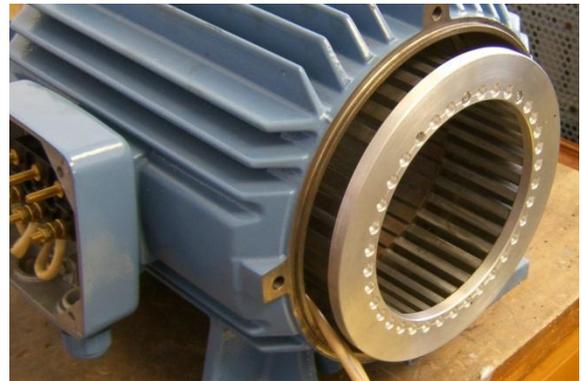
As Figure 3 shows, the cage has been built longer than the designed stator windings in order to have a better access to the rings and the ends of the bars, and to leave some clearance with the aim of installing current sensors around them.

Fig. 3– Stator of the inverted induction motor.

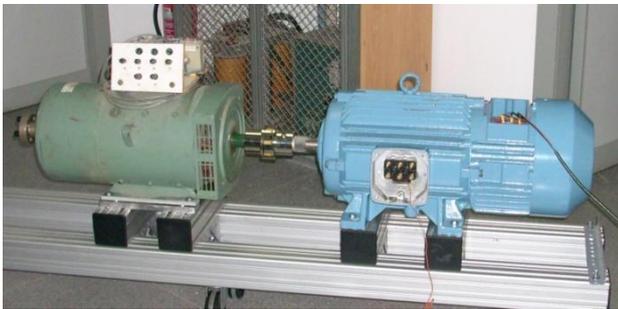
The longer bars and wide rings have prevented the use of the connection box for feeding the machine, thus, the brushes in the aft section are connected directly to the control and measurement devices (Fig. 5). Nevertheless, the connection box and associated empty spaces behind

The inverted motor has been mounted on a wheeled lightweight frame having longitudinal slits and detachable joints for providing the flexibility needed for a rapid access to the cage. Further equipment is being studied to perform this operation *in situ*.

Fig. 5 – Test stand.

In order to carry out tests in its entire loading range, the motor is coupled to a 15 kVA alternator. Table II provides its main characteristics.

The overall control of the induction motor and the alternator is performed by a PLC which allows for testing any working cycle of the induction machine. Data acquisition is achieved by a Yokogawa DL-750 multichannel recorder.
