# On-site Assessment of High Voltage Motors Insulation Operating in Oil Facilities

**Abstract.** Thirteen motors rated at 13,8 kV and 2500 H. P. of capacity installed and operating in a critical Oil Pumping Plant, were evaluated on-site, to determine the insulation system condition and schedule a maintenance program. This on-site assessment was based on a non-invasive and non-standardized ultra-wide band partial discharge technique developed. The results obtained allowed motors insulation system status classification, according to partial discharges measured on ground connection of the main cables of the motor, employing near field sensors. A traditional N-Q- $\Phi$  Partial Discharge pattern is obtained to facilitate motor insulation system problems identification. The results of this on-site motor assessment, during normal operation, and its application on maintenance programs are presented and discussed in the paper.

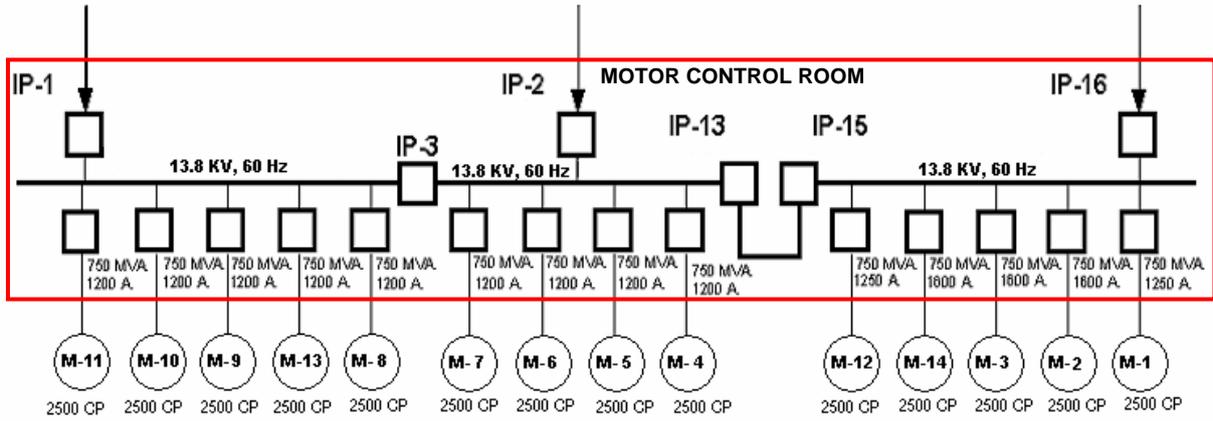
Fig. 1. Electrical single diagram of the assessed motors

The Figure 1 shows the electrical single diagram of the oil pumping facility where the assessed motors are installed. The Figure 2 shows an overview of this facility. The power supply to the motors is provided through insulated power cables, installed in trenches.

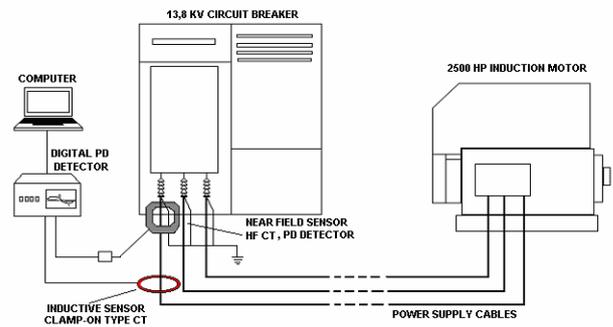
Fig. 3. Test circuit for high voltage motors PD detection.

The electrical circuit for the motor evaluation, based on ultra wide band techniques, is shown in Figure 3.

The PD measurement was carried out placing a "clamp-on" Rogowski type sensor with a bandwidth of up to 40 MHz, in the main power cables of the motor at the breaker side, located in the motor control room. For the PD readings, conventional equipment for detecting partial discharges is used. This measurement equipment consists of an acquisition and signal processing unit. The obtained signals through the near field sensor are conditioned through a pre-amplifying unit, which changes the characteristics of measured signal of UWB to conventional for reading in a conventional detector. This detector displays the measurement in a PD type N-Q-Φ pattern [6]. The Figures 4 and 5 show the test circuit on-site physical implementation.

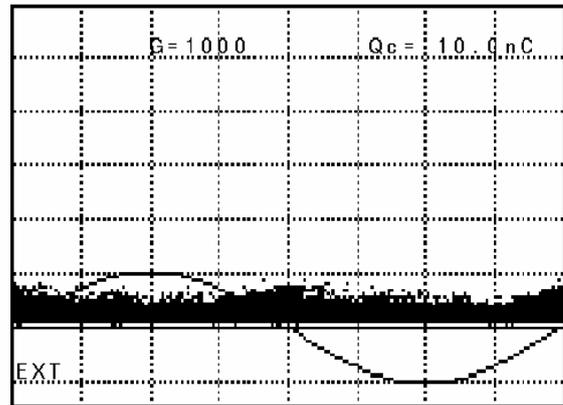
Fig. 6. Motor M-1 PD pattern, 10 nC Max.

The PD pattern shown in Figure 6 shows the PD activity map obtained in phase 1 of motor M-1. At this phase was

measured a maximum charge of 10 nC, which was the lowest PD level measured on-site.

This value indicates that the motor insulation system is in good conditions and can operate normally. Other assessed motors whose insulation are on acceptable conditions to continue in operation, were motors M-3, M-4, M-7 and M-12.

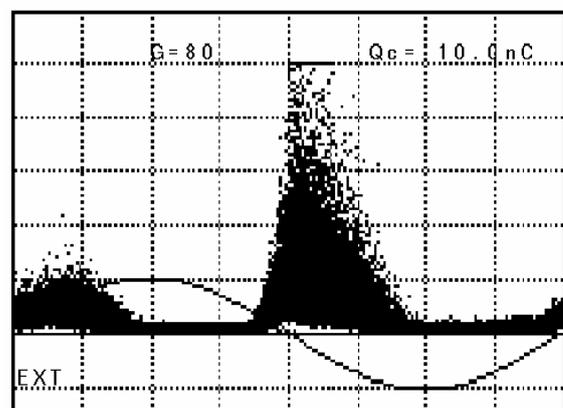
Fig. 7. Motor M-14 PD pattern, 570 nC Max.

The obtained results show, that identified M-14 motor, has the highest level of partial discharges (570 nC), while the M-1 has the lowest value (10 nC). The information obtained from the maintenance records, shown that both motors were repaired and their windings replaced. However, it appears that the quality of the motor winding M-14 repair was lower than that of the motor M-1, or that during normal operation at the motor M-14 have been initiated one or more deterioration mechanisms, which are causing a high level of PD.

The PD pattern shown in Figure 7, shows the PD activity map obtained in phase 3 of motor M-14. It distinguishes that PD in the negative semi cycle are greater than those of positive in 5:1 relationship. This pattern and the high level of DP (570 nC) according to [8], is typical of the activity of slot partial discharges (PD between coil surface and stator core laminations). Phases 1 and 2 also presented this behavior, although with reduced levels of 180 nC. This mechanism of deterioration is the most severe, from the electrical insulation point of view; the partial discharges erode the main insulation decreasing its lifetime.

The recorded PD magnitude in this motor is extremely high. Given that this type of PD can lead to the failure of the insulation, its immediate shut down to test its windings and avoid a fault was recommended.

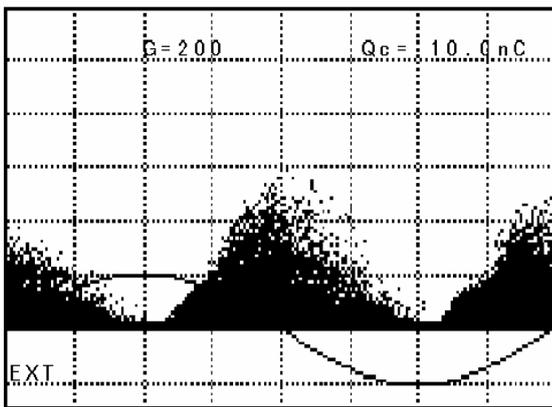
Fig. 8. Motor M-13 PD pattern 120 nC

The Figure 8, shows the pattern of the PD activity map obtained in phase 2 of motor M-13. This PD pattern is different to that obtained in the motor M-14. The partial discharges have similar magnitudes in both semi cycles, so it is clear that this is a different deterioration mechanism.

This PD pattern was recorded in the motors M-9 and M-13 with similar magnitudes 120 nC in one phase of each motor. Even when these motors presented values of similar PD, its maintenance record is different, the motor M-9 keeps its original winding, manufactured 20 years ago, while the engine M-13 has a recently repaired winding.

In both motors the pollution deposited in the end windings can be the PD cause; the pollution avoids the correct graduation of electric field. Another cause may be the deterioration or incorrect stress grading coating application (in the case of the repaired motor). In the case of the Motor M-9, the high magnitude of partial discharges can be caused by the separation of insulation tapes. These motors are recommended for inspection and end winding clean up or reapplications of stress grading coating.
